A Case Study

In-Situ Tailshaft Machining

Background To The Tailshaft Repair

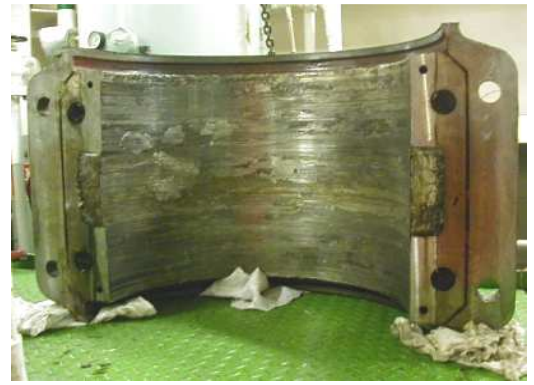
The white metal bearing had failed leading to pickup and areas of deep scoring. Micrometer readings showed an undamaged area at each end of the journal. These proved suitable for use as datums for the orbital machining and polishing operation.

Damaged White Metal Bearing

Use in-situ machining and polishing to remove all signs of damage, whilst maintaining concentricity and roundness within OEM tolerances. Obtain undersize bearings to suit the repaired journal.

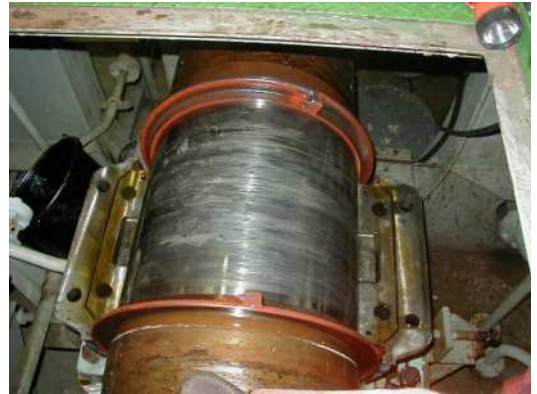
The Moscow had a failure on its 505mm diameter (400mm long) tailshaft pedestal journal. Nicol & Andrew were called in to re-machine the damaged journal in-situ, using specialised orbital equipment.

Damaged 505mm Ø Tailshaft Journal

We used our orbital machining head to remove the damage, referencing the undamaged concentric areas at each end of the journal. Frequent checks using clock gauges ensured that the re-machining was maintained in perfect alignment with the original. We then polished the tailshaft to the size and surface finish required for the undersize bearings.

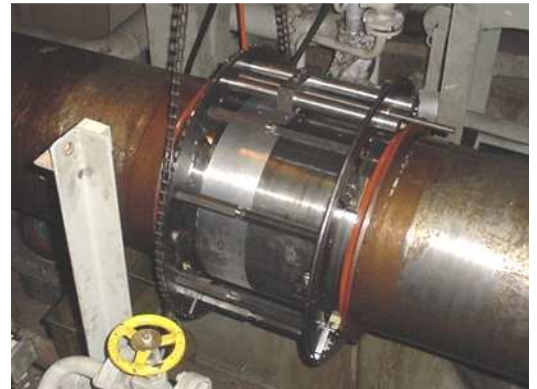
Orbital Machining Of The Journal
