Turbine Journal & Hydrogen Seal Repairs

Repair Examples from UK Power Stations

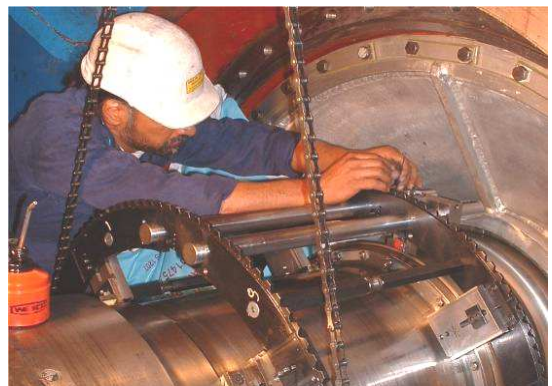
Machining and Polishing of a 610 mm \varnothing Hydrogen Seal Face

Machining and grinding of Hydrogen seal faces is performed in-situ to repair scoring and any swash present in the face. We have designed equipment over the years to cope with almost any configuration and size of face. Flatness will be held within .025 mm TIR (with respect to datum's provided) with a measurable surface finish of 0.3µM Ra.
